SECRET**PROGRESS REPORT**

Period of June 1 to June 30, 1963

Contract No. AF33(600)40280

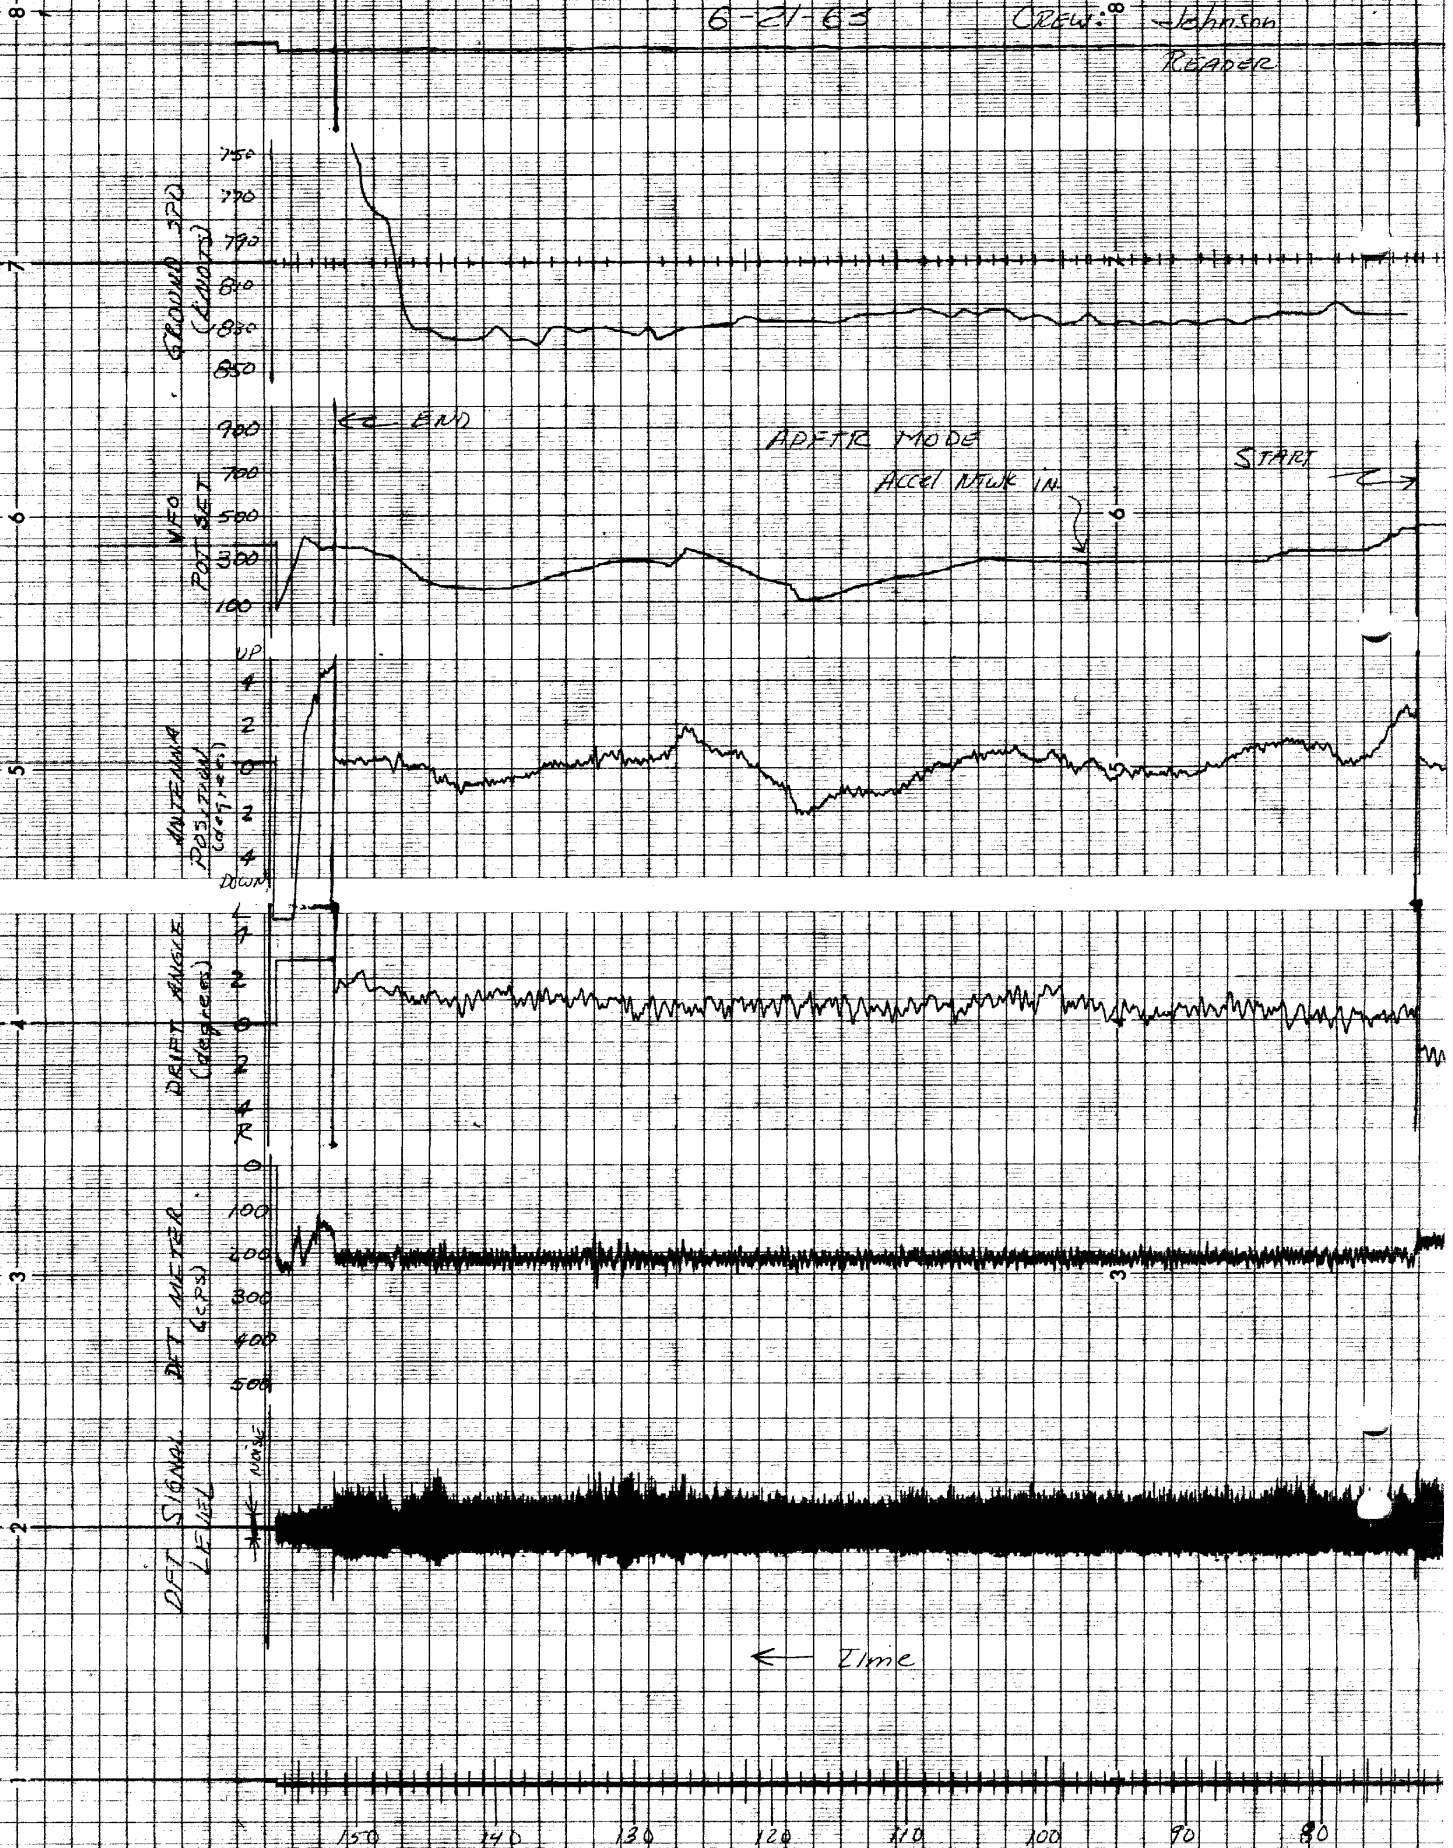
FLIGHT #64
6-21-63

Magnetic instrumentation configuration has been modified for "quick-look" data; an example of the recording is shown in Figure 1. This recording is prepared by transcribing in-flight magnetic tape recordings on paper through an ink recorder.

High Alt.
CREW: Johnson
Reader

Instrumentation recordings indicate some difficulty in obtaining and maintaining DFT lock-up caused by aircraft accelerations. Steps have been taken to minimize the acceleration.
